## **Design and manufacture of protective elements to prevent accidents in the agricultural machinery of Ecuador, two cases of study in automotive elements.**

Edison Marcelo Castillo Cárdenas.<sup>1</sup>, Víctor David Bravo Morocho.<sup>2</sup>, Edison Patricio Abarca Pérez.<sup>3</sup>, Edgar Fabián Sánchez Carrión.<sup>4</sup> & Paúl Alejandro Montúfar Paz.<sup>5</sup>

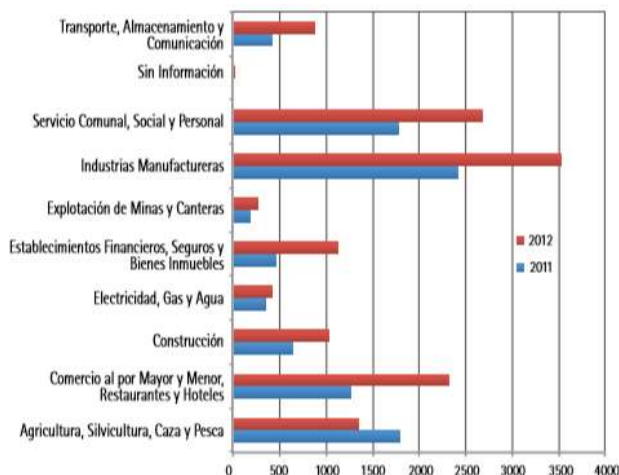
**Graphic 1.** Number of work accidents according to work activity.

The incidence of occupational accidents within the agricultural machinery is an important aspect to be taken into account in the industry is the fourth group in number of work accidents (TA) behind the manufacturing industry, community and social service and commerce in general ( figure 1), "According to the data of the Agrifood Statistics Yearbook in 2009, both in the agri-food industry and in agriculture, annually more than 30,000 workers are involved in accidents during their workday" the data is from Spain. [4].

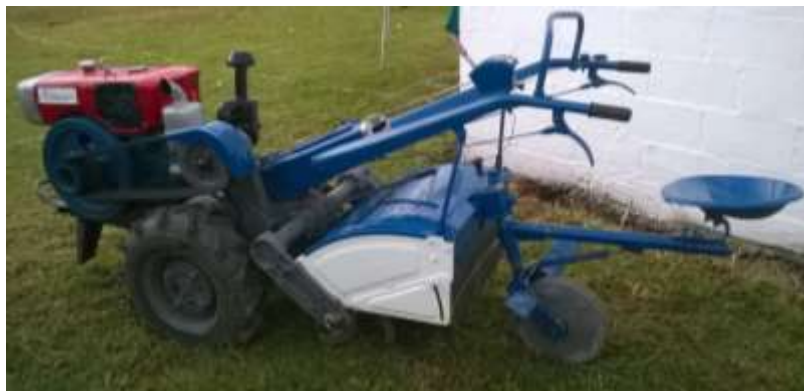
**Graphic 2.** Study walking tractor

The theme of the crank and the ignition is crucial since many of the agricultural activities are carried out by both men and women and sometimes horticultural work is carried out to a greater extent by women, therefore, a system should be available. of ignition that is light (in agreement with the standard average force that an average woman can exert), high index of reliability (often the ignition is ignited to the three or four cycles of attempt of ignition) or when the climate is cold it is likely to be tried for a long time there are cases of more than one hour, this generates waste of time and is generating in farmers the idea that it is an impractical and reliable system for their activities, should be the ignition system easy to maneuver: with the current system of crank some steps have to be carried out for the ignition of the automotive system that is purely mechanical, first it has to turn the accelerator knob of the tiller (figure 2), second the fuel valve must be calibrated, third the front support of the tiller must be lowered to stabilize it and fourth the crank base must be inserted in the notch and finally it has to be turned to a torque and a high effort speed to overcome the inertia of the rototiller and to turn it on.

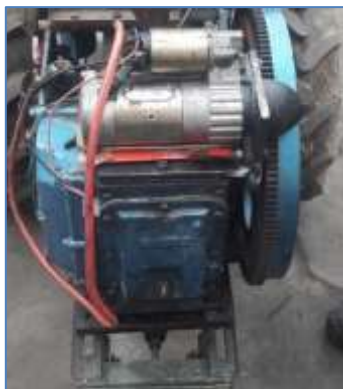
**Graphic 3.** Starter assembly and cogwheel of the flywheel.

The inertia flywheel of the tiller was machined so that on its periphery is placed a toothed crown that is in accordance with the bendix (cogwheel connection with the flywheel) of the starter (that the teeth of both the ring gear as of the starter they can mesh with each other without difficulty, which can not be too loose or too tight), as can be seen in figure 3, then the selection of the ideal starter for the proposed equipment was made if

A starter has been selected after the following deliberations: environmental conditions, protection index, installation arrangement, nominal power, work cycles, rotation speed, efforts required to expire; a starter motor of 3.5kW (figure 6) equivalent to approximately 4.7HP, it should be noted that said engine was selected in accordance with the theory that indicates that the minimum power of a starter is equal to the sum of the power to start the thermal engine plus the power consumed by the starter, although this data is important is not also commercial items that are in stock, initially selected a starter with less power and weight one of approximately 3HP but its teeth were incompatible with the cogwheel of the

flywheel so that the engine of 4.7 HP was finally selected since its bendix fitted perfectly with the gear described.

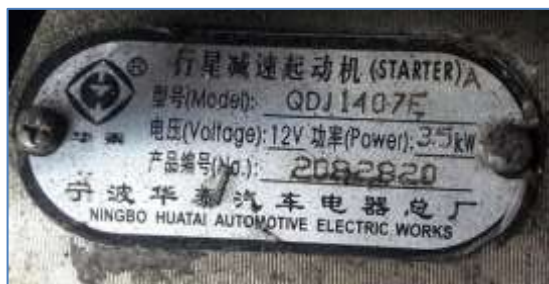
**Graphic 4.** Technical data of the starter motor.

Some critical aspects are considered at the time of selection such as: environmental conditions, electrical protection index (in this case it does not apply since it is direct current), installation disposition (in this case it is an adaptation and it is probable that it does not have support devices to the original base), nominal power (perhaps the most important since it must move and drag a 16HP heat engine [7]), the work cycles (relatively low since it will only influence the ignition of the tiller), rotation speed (in this aspect it is common for starters that their torque is high but their rotation speed is low), efforts and loads to do the job (the starter will not be subjected to greater efforts), there is to say that both the starter motor and the rototiller are of Chinese origin as shown in figure 4.

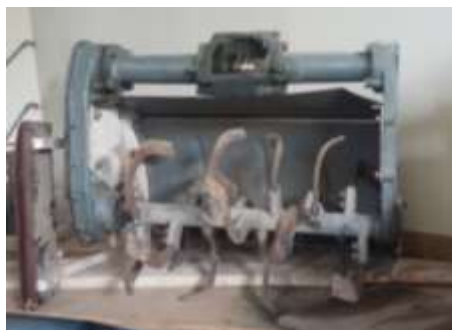
**Graphic 5.** Rotavator with blades

As mentioned in previous lines, another of the most pressing problems is the breaking of the blades, this problem occurs because the Chinese walking tractor was designed exclusively to till the soil destined for rice cultivation in its country of origin and therefore the benefits are different, the average hardness of the soil is totally different and the working conditions are different: while in Ecuador it has been tried to use the tiller to break the firm soil and more or less humid the other side of the coin is in China where these machines are used to prepare the soil with a view to planting rice. The farming organ with which the producer exports is the classic "rotavator" or known in Spanish as a floor milling machine or simply a milling machine, you can see its appearance in figure 5.

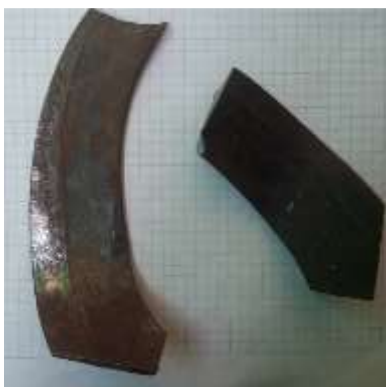
**Graphic 7.** Remains of an underground blade.

After fracturing the blades of the milling machine, the residues are in two parts, the first one is trapped in the milling box between two bolts and the other part remains on the ground generating two imminent risks. The first is the danger of cutting. sharp and sharp edges remain as can be seen in figure 7.

The second danger is that in a next pass of the machine for the place where the remains of the blades are, it can hit the milling machine and generate more ruptures and these remains can be fired towards the farmer.

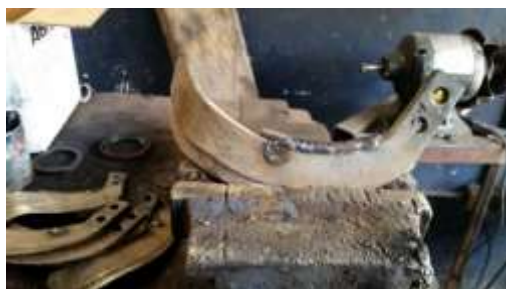
**Graphic 10.** Added blades material.

The solution that was reached after performing both destructive and non-destructive tests (hardness of the material, metallography, ultrasound, penetrating inks, simulation in CAD-CAE software) was to add material to the critical area and was simulated in the software to know how was their behavior, it was found that with the reinforcement by means of material would not suffer, said procedure consists of two parts: a) place a piece of commercial steel rod construction of a quarter inch in diameter convex of the blade and b) then fill it with weld bead with electrode 6011, this procedure was chosen since it was worked in the construction of another blade in an artisanal way but the cost benefit was low, then the exposed solution was the most viable from the point from a technological and economic point of view, both points were very important since welding is a technology that can be used in the middle and in terms of torque, you could use the same blades economically and then with a reasonable investment reach a good cost-benefit balance, you can see the new blades with the addition of material in graph 10.

Finally, after adding material to the study blade as indicated in the methods section, the value of the deformation in the most severe condition (heavy soil) is 0.25 mm; with which it can be shown that the solution was efficient, adding to that already in the field there were no problems and with this it was evidenced that the new reliability index was 1.

The solution of the addition of material in the blades of the rotavator has been implemented and in the field tests carried out, no breakage has been determined so that it can be asserted that the solution was also effective, this implies that the risk of suffering injuries for the pieces of buried blades was eliminated.

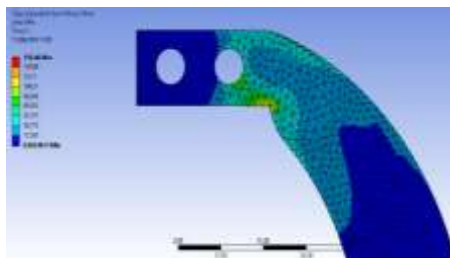
**Gráfico 11.** Simulation of the blade in normal conditions (without adding material).

With the original blades of the tiller, a deformation of 1.9 mm is presented in the software simulation, which, extending the stress towards the stress concentrators (fixing holes), generates the fracture, as can be seen in figure 11.
